Manhole Inspection Summary

Manhole # S33G__019MH

Insp Date: **12/15/08 11:17 AM**

Location Address: **201 hopkins place** Cross Street: **e. baltimore st**

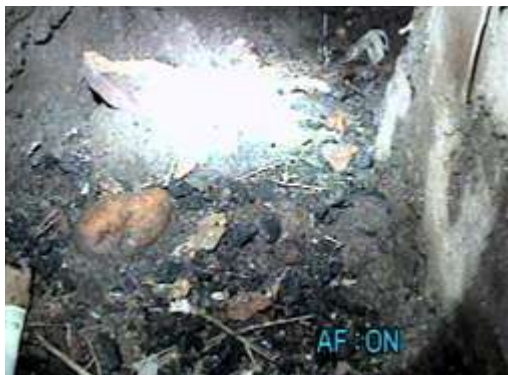
Miscellaneous

Condition: ☐ Sound ☐ Cracked ☐ Root Intrusion ☐ Deteriorated ☐ Leaks ☒ **Debris**

channel debris

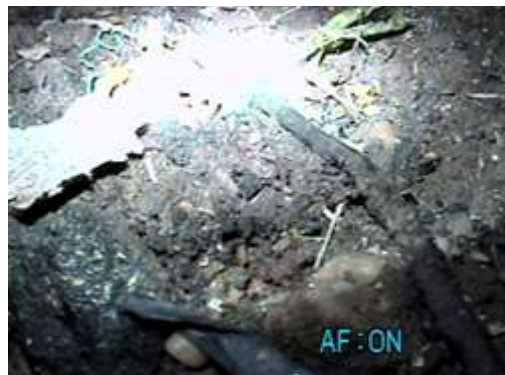
Miscellaneous

Condition: ☐ Sound ☐ Cracked ☐ Root Intrusion ☐ Deteriorated ☐ Leaks ☒ **Debris**

bench debris

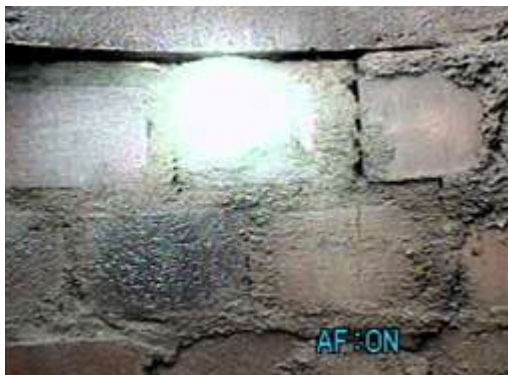
Defect 3

Condition: ☐ Sound ☒ **Cracked** ☐ Root Intrusion ☐ Loose Brick ☐ Deteriorated

chimney cracked

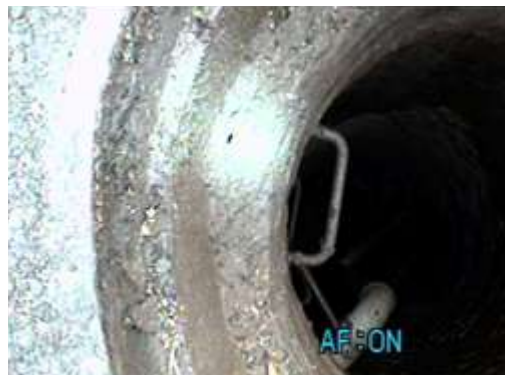
Defect 2

Frame Offset: **2** (in.) Condition: ☒ Sound ☐ Cracked ☐ Leaks

frame offset 2 inches

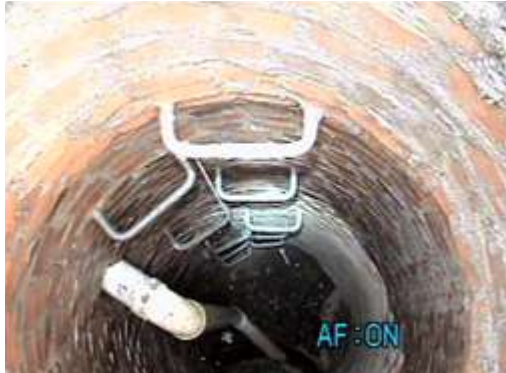
Defect 1

Steps Count: **10** Missing: **0** ☒ **Corroded**

corroded steps
